# Manhole Inspection Summary

Manhole # S09UU\_004MH

Insp Date: **3/19/09 10:44 AM**

**Location** Address: **3301 LIBERTY HEIGHTS AVE**

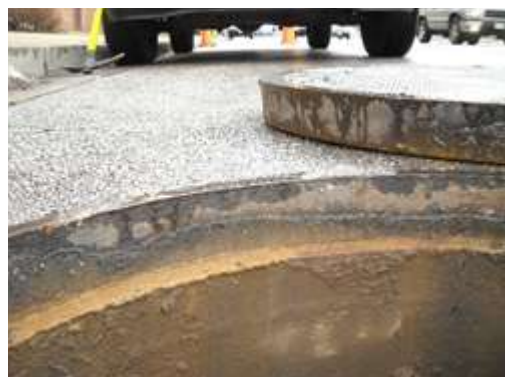
Subject To Ponding: **Sheeting**

EVIDENCE OF INFILTRATION DUE TO SHEETING FROM THE CROWN OF ROADWAY

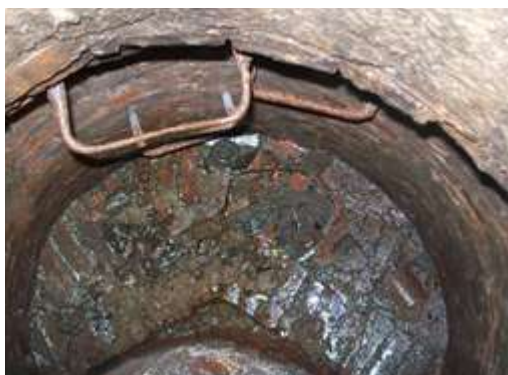
Defect 4

DEBRIS ON BENCH

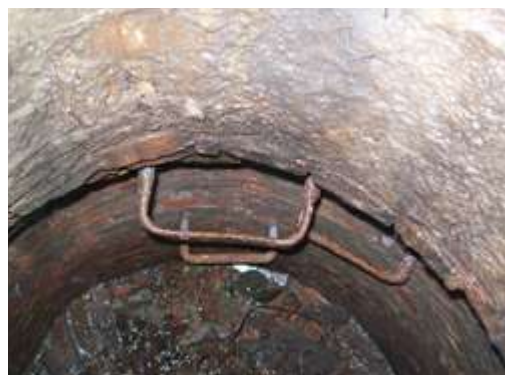
Defect 3

Count: **2** Missing: **0** ☒ **Corroded**

☒ **Evidence Of Surcharge** Depth: **1** (ft.) ☐ Active Surcharge Present

CORRODED STEPS; EVIDENCE SURCHARGE

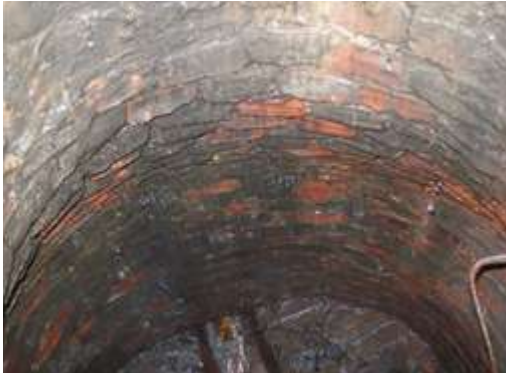
Defect 2

Infiltration: ☐ None ☐ Joint ☐ Cracks ☐ Mortar ☐ Roots ☒ **Wall**

INFILTRATION BARREL AND CORBEL

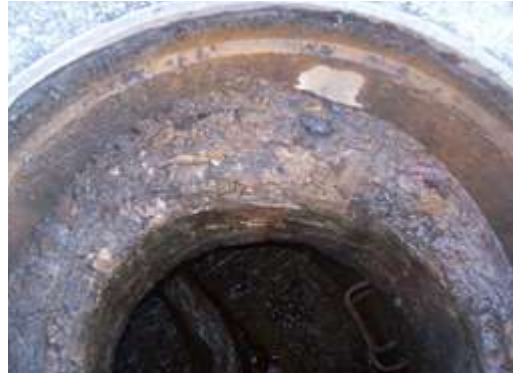
Defect 1

Offset: **6** (in.)

FRAME OFFSET

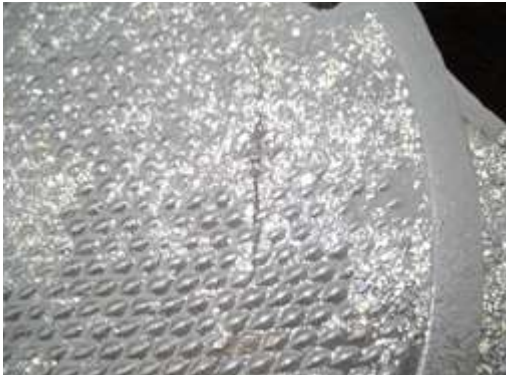
Defect 2

Condition: **Cracked**

30" CRACKED SANITARY LID

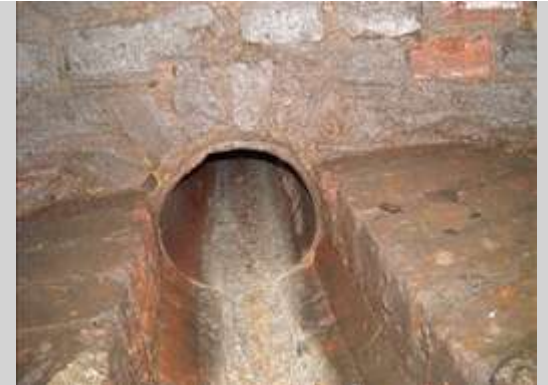
12 O'Clock Outflow

8 in. Circular Gravity Sewer  
Pipe Out @ 12 O'Clock

Pipe Height: (in.) Direct  
Pipe Material: **Clay** ☐ Pipe Lined  
Invert Depth: **7.50** (ft.) Flow Characteristics: **Fast**  
Deposits: ☒ None ☐ Mud ☐ Sludge ☐ Debris ☐ Grease  
Silt Depth: (in.) Deposits Extent:  
Infiltration: **None** Pipe Seal Cond: **Sound**

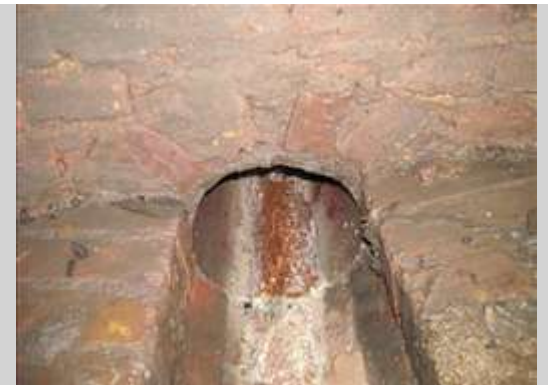
7 O'Clock Inflow

8 in. Circular Gravity Sewer  
Pipe In @ 8 O'Clock

Pipe Height: (in.) Direct  
Pipe Material: **Clay** ☐ Pipe Lined  
Invert Depth: **7.30** (ft.) Flow Characteristics: **None**  
Deposits: ☒ None ☐ Mud ☐ Sludge ☐ Debris ☐ Grease  
Silt Depth: (in.) Deposits Extent:  
Infiltration: **None** Pipe Seal Cond: **Sound**
